Sedimentation History of Halfway Creek Marsh, Upper Mississippi River National Wildlife and Fish Refuge, Wisconsin, 1846–2006

Scientific Investigations Report 2007–5029

By Faith A. Fitzpatrick, James C. Knox, and Joseph P. Schubauer-Berigan

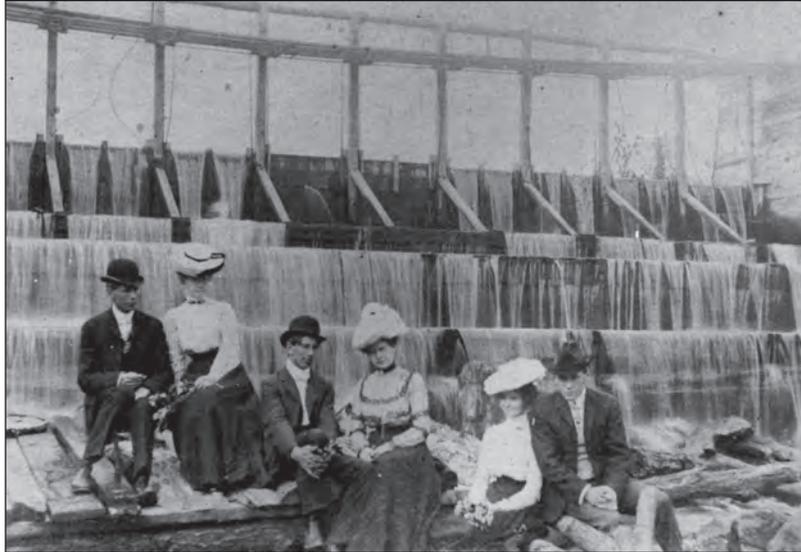
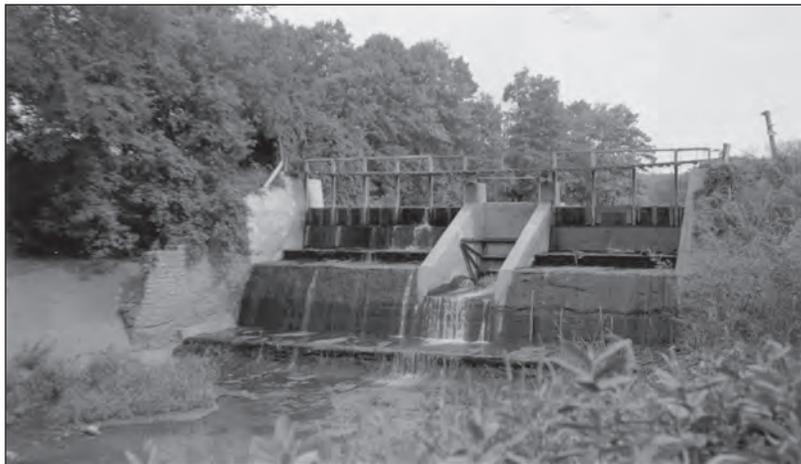
Figure 4. Holmen Dam around 1890 (Olson, 1962), 1919, and 1937 (Wisconsin Department of Natural Resources Dam Field File #32.02).

Further changes to the Holmen Dam were made between 1931 and 1937. A 10-ft-wide taintor gate was added to the center of the Holmen Dam in 1935 (fig. 4). The water levels in the millpond increased by about 2 ft between 1931 and 1937. In 1937, the mill pond at Holmen was about 0.75 mi long and 150 ft wide, covering about 13.5 acres (Wisconsin Department of Agriculture and Wisconsin Geological and Natural Survey, 1938). The Holmen Dam washed out in 1957 (based on dam inspection notes) and was not replaced because by 1957 the mill was electric powered. In 2005, the authors found some remnant pieces of concrete and steel along Halfway Creek at the original site of the Holmen Dam.

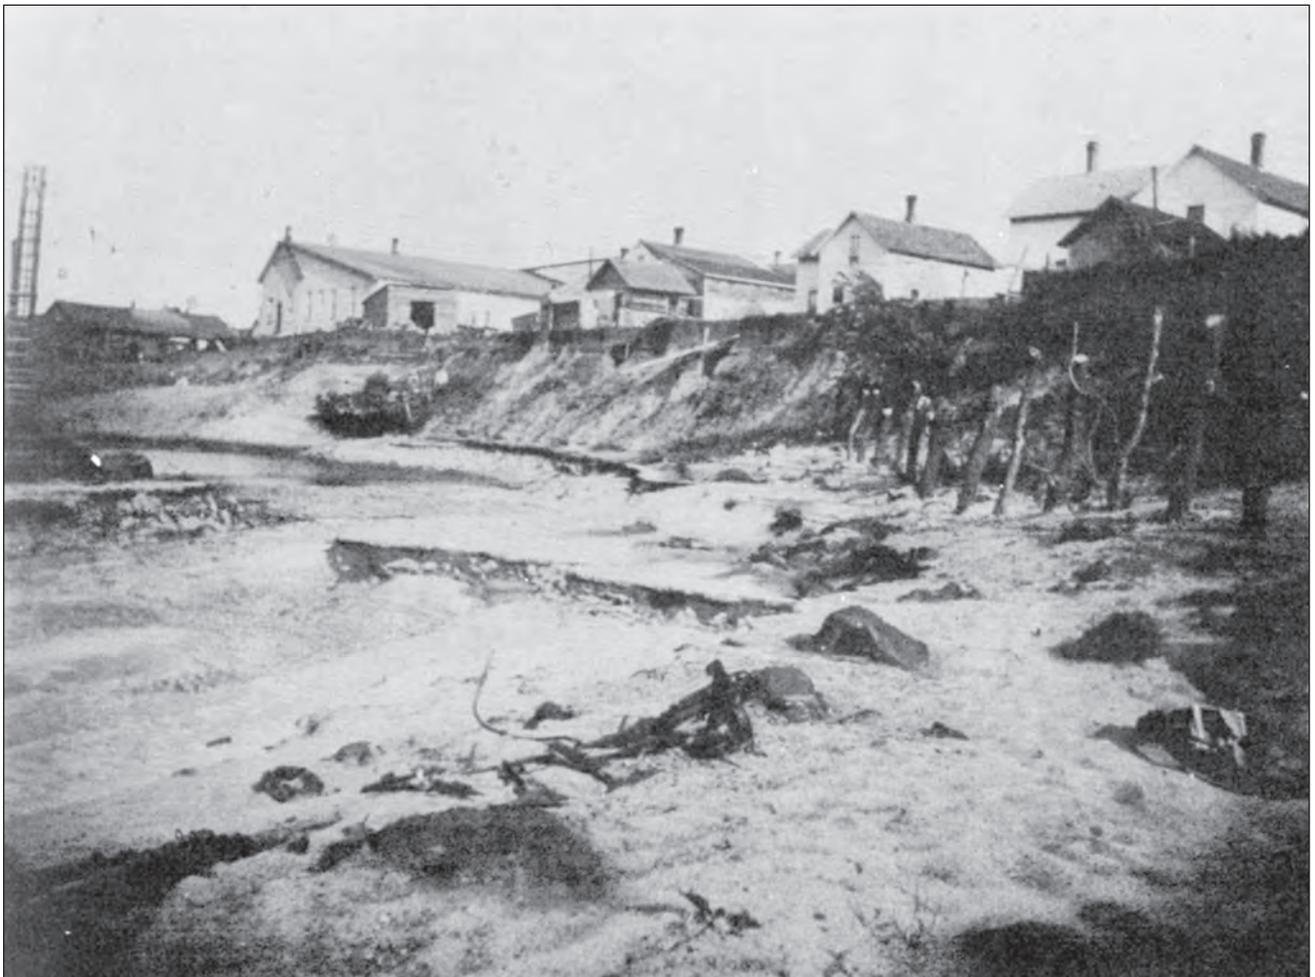
Figure 5. Halfway Creek near Holmen, Wis., after the 1899 flood (Olson, 1962).

the impoundment upstream of the dam caused by the flood (fig. 5). Dam-inspection notes indicate the dam was rebuilt in 1898 with a combination of concrete, timber, and earth. It is likely that the dam was rebuilt after it was washed out in the 1899 flood; it is not known if the date for the rebuilt dam should be 1899 or whether the dam was rebuilt two years in a row.

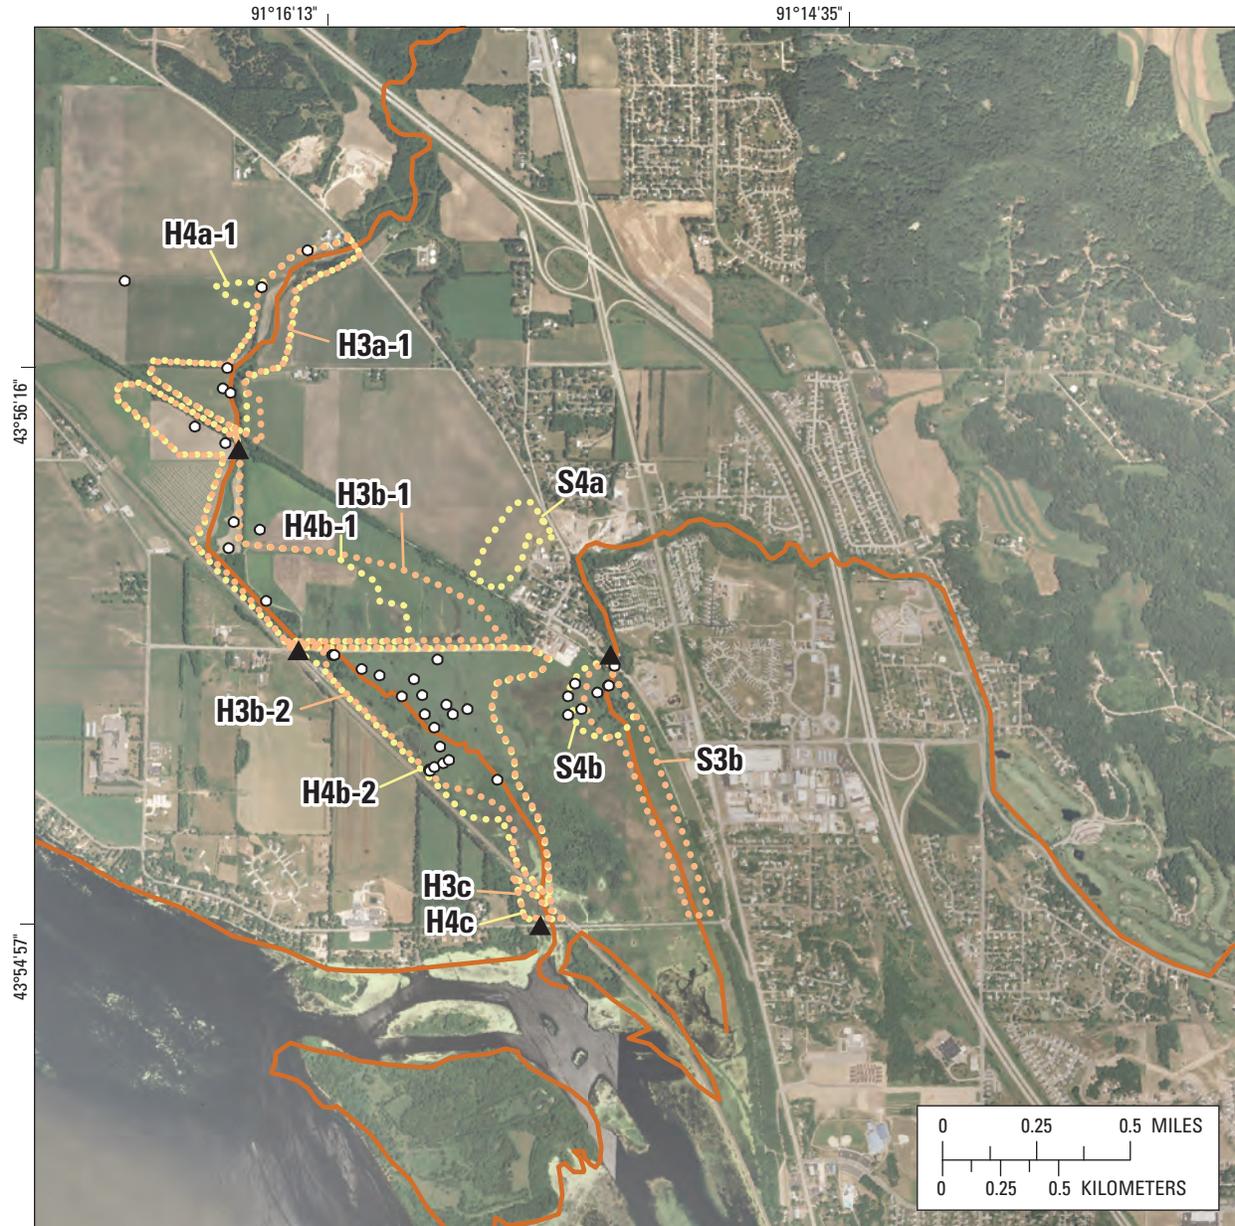
Figure 6C. Historical changes in channel locations and potential subareas with overbank sedimentation along Halfway Creek Marsh, Wis., for period 3 (1919–1936) and period 4 (1937–1969). Overbank sedimentation volumes for labeled potential subareas are listed in table 2.
